# The Chitrakarini Temple of Bhubaneswar (Odisha, India): An Investigative Field Study

## Abstract

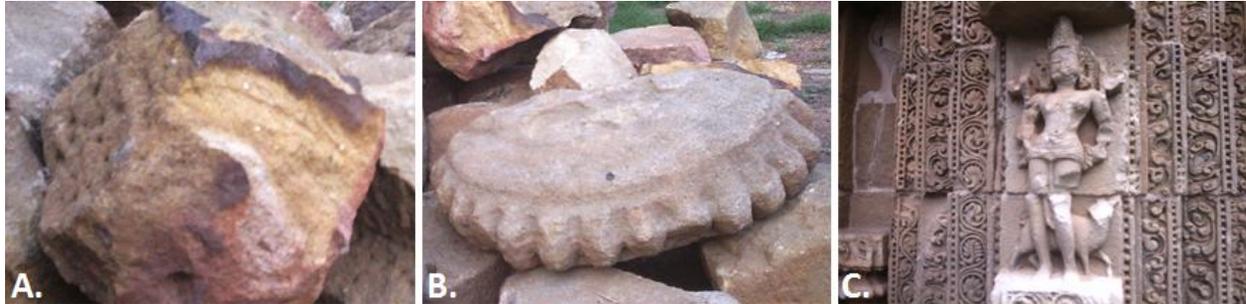
**Image-4: (A.) Raw sandstone block, (B.) A carved sandstone block available in Mahakaleswar Temple premise, (C.) Sculpted sandstone wall of Chitrakarini Temple (Photography by author)**

Sandstones are nature made common sedimentary rocks, composed of sand particles, minerals and other locally available other variants<sup>21</sup>. Most of the Odisha sandstones are made up of the broken particles of the Deccan Plateau<sup>22</sup>, and are available in red, orange reddish yellow and pink etc. like colors variations. Sandstones of Odisha, carries clearly visible weather-marks or grain lines<sup>23</sup>, and different types of coastal wind reactive components<sup>24</sup>. These stones are suitable for handcraft<sup>25</sup> and creative sculptural expression<sup>26</sup> purposes through chiseling<sup>27</sup> and other related craft processes. Probably that's why, sandstone had been used as the primary construction material for building *Chitrakarini* temple premise's all five shrines.

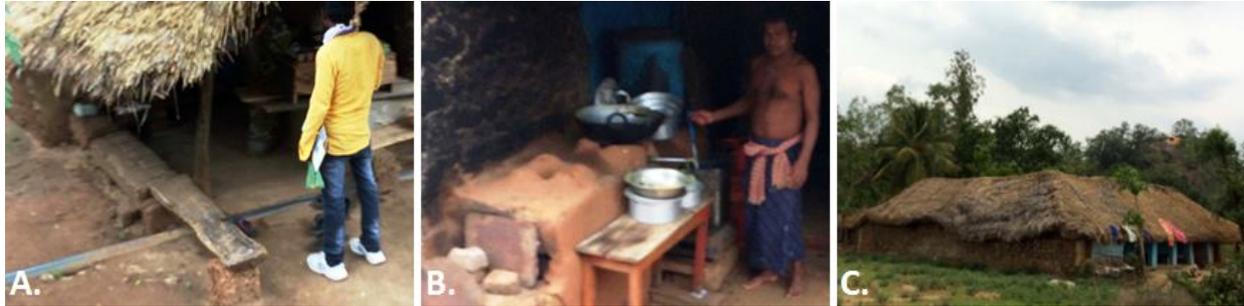
**Image-5: Some native uses of laterite stone blocks: (A.) Used as seating base in a local tea stall along with flat wooden slabs, (B.) Laterite stone block made fireplace in a village restaurant-plastered with clay, (C.) A complete house made up of laterite blocks (Photography by author)**

Laterite stones are locally known as ମାଙ୍କଡ଼ ପଥର or *Mankad Patthar*; and are being used for building contemporary houses as well used for other diversified daily life uses by the local residents. Few local uses of laterite bricks could be seen in image-5. Since long back, Laterite stone bricks had been used as a construction material<sup>28</sup> in Odisha and so found used in constructions of the studied temples. Laterite decompositions are usually available near the earth crust, and are easy to be extracted, and further cutting into symmetric cuboidal bricks. There is a vast decomposition of laterite stone in different nearby locations within the Odisha sate.

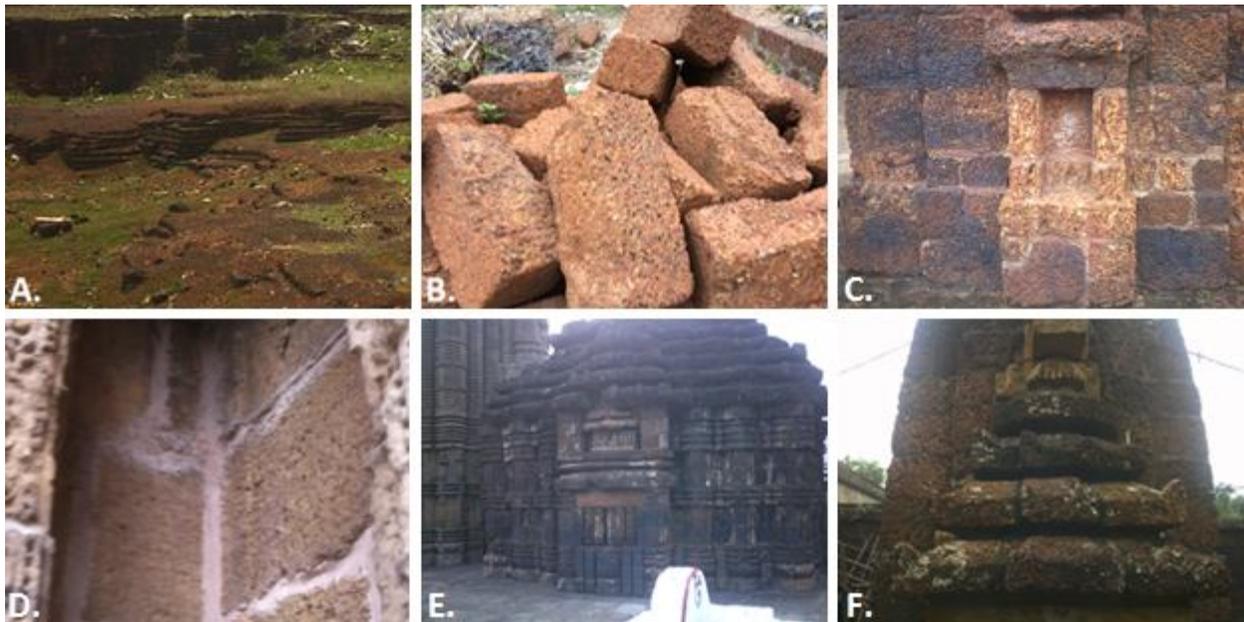
The laterite bricks were mostly used for constructing external boundary walls of the studied temples in common- including *Chitrakarini* temple. However, as observed, few shrines were completely constructed using laterite bricks, with minimal carvings; please refer image-6(E&F). These bricks had also been found used for constructing ladder steps, footpath constructions, and in wall constructions in different studied temples. As well these stones were also used for the purposes of wall repair and reinforcement in these temples- where original walls got poorly damaged.

**Image-6: (A.) Post-extracted view of a laterite mine, (B.) Rectangular-cuboidal brick blocks of laterite, (C.) A Laterite constructed complete wall panel in Pappashini Temple premise, (D.) A wall panel of Chitrakarini Temple restored using laterite bricks, (E.) Pappashini Temple's entire Jagmohan shrine built using laterite bricks, (F.) A complete peripheral shrine in Mahakaleswar Temple campus built using laterite bricks (Photography by author)**

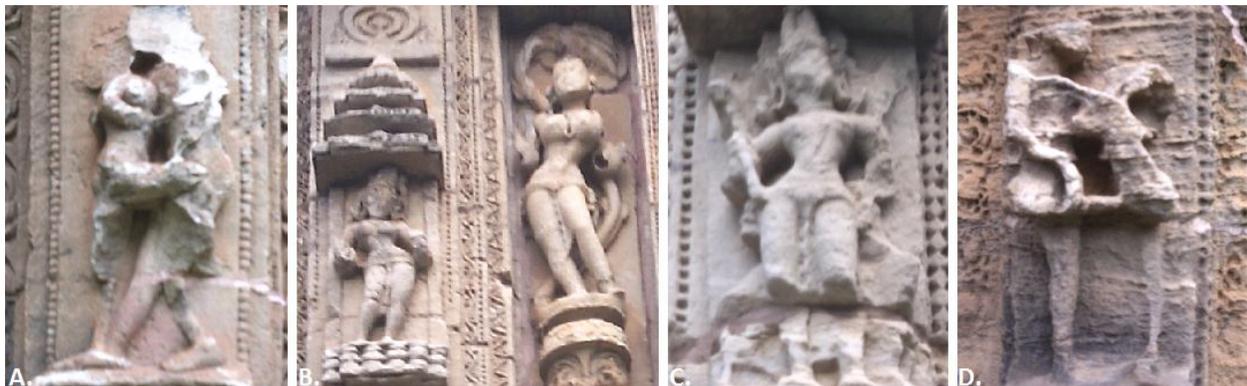
**Image-7: (A.) Pair of human form with chiseled broken head, (B.) Two different leady forms in original condition displaying *Hashy Ras* and *Shringar Ras*, (C.) Half damaged lord Vishnu form displaying *Vir Ras*, (E.) Due to nature caused, local climatic conditions faded sculpture of unidentified human forms<sup>41</sup> (Photography by author)**

Sculptures displayed in image-7(A,C&E) were found within 15 feet's vertical height range from the temple's foundation over wall panel; while the sculptures displayed in 7(B) were found above 15 feet's vertical height range from the *Chitrakarini Temple* foundation.

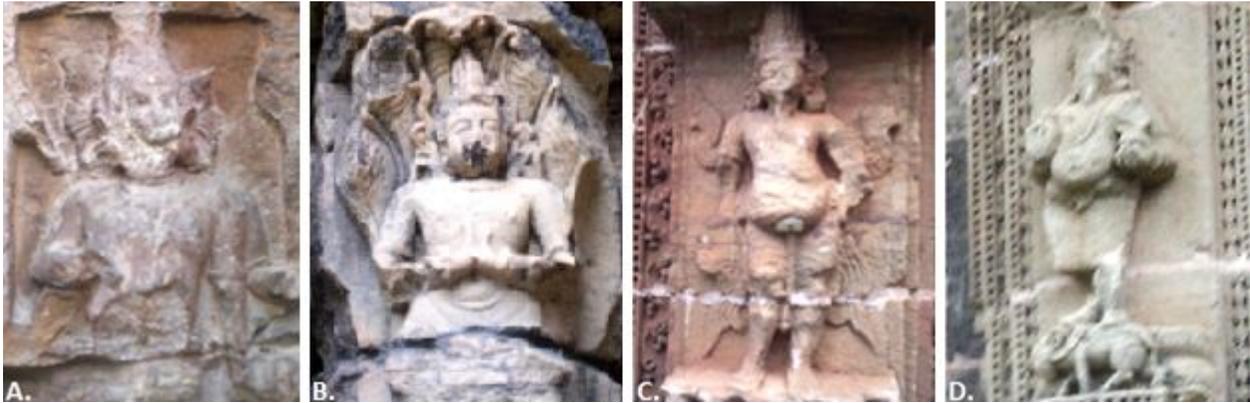
**Image-8: Sculpted forms of human-animal fused mythological Hindu deities available on the walls of Chitrakarini Temple: (A.) God Narsing, (B.) God Shashnag, (C.) God Garud, and (D.) God Ganesh (Photography by author)**

God *Narsing*<sup>42</sup> is considered as a Hindu god and is regarded as a form of lord Vishnu. In this mythological sculpture, lion's upper halves got fused with a human body. Please refer image-8(A).

God *Sheshnag*<sup>43</sup> is a Hindu mythological snake god's form, having seven heads. In this mythological sculpture, human's upper half got fused with the Nag Snake's lower body part. In this temple, a wide range of different female snake forms had also been found sculpted-representing different forms of goddess *Vimala Devi*<sup>44</sup> or *Nag-Lakshmi*<sup>45</sup>. She was the wife of *Sheshnag*; please refer image-8(B).

In Hinduism, God *Garud*<sup>46</sup> had been considered among the prime support to lord *Vishnu* and considered as the most powerful king of birds. In a sculpted form, *Garud*'s main body had been represented with two pair of wings on his back side, along with a bird's face which was fused with a human body. In this sculpture, face was found damaged and its beak part was lost. Please refer image-8(C).

elephant and not over a Rat! This is contraindicative with the popular *Shivism* style of Ganesh's representation, where God *Ganesh* get represented riding over a Rat! Please refer image-8(D).

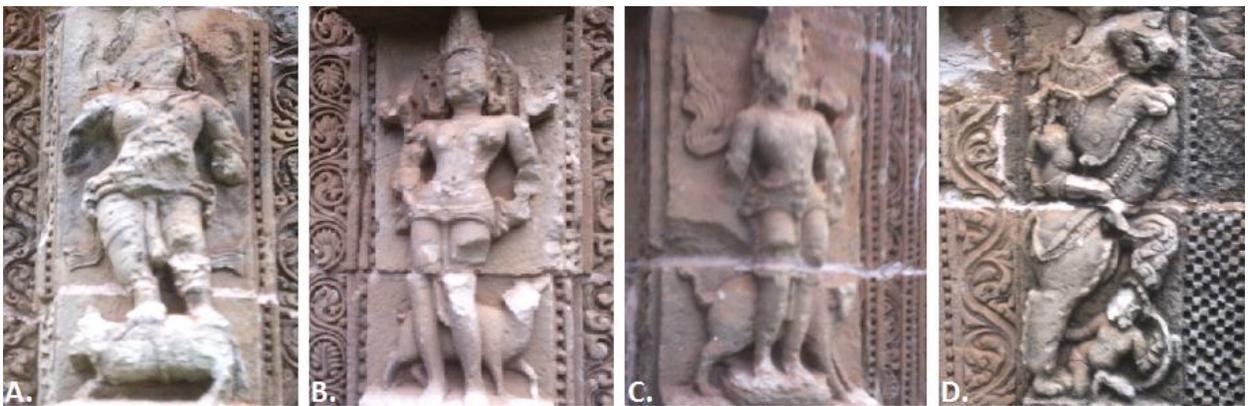
**Image-9: Sculpted forms of human and animal interactive forms from the walls of Chitrakarini Temple- (A.) Pig with man, (B.) Goat with man, (C.) Monkey with man, and (D.) Lion with two men (Photography by author)**

In addition to above human-animal fused Hindu mythological forms, interactive human-animal forms had also been carefully sculpted over these wall panels. But as majority of the sculptures of this series, were found poorly damaged in *Chitrakarini Temple*, so this was quite difficult to identify the subjected form of deities. However, on the basis of studied body gestures of the subjected forms, this could be speculated, that in image-9, (A.) is a Pig similar form, (B.) is a Goat similar form, (C.) is a Monkey similar form, and (D.) is a Lion similar form etc. had been sculpted. The sculpture of elephant riding *Ganesh* could also be included in this series, please refer image-8(D).

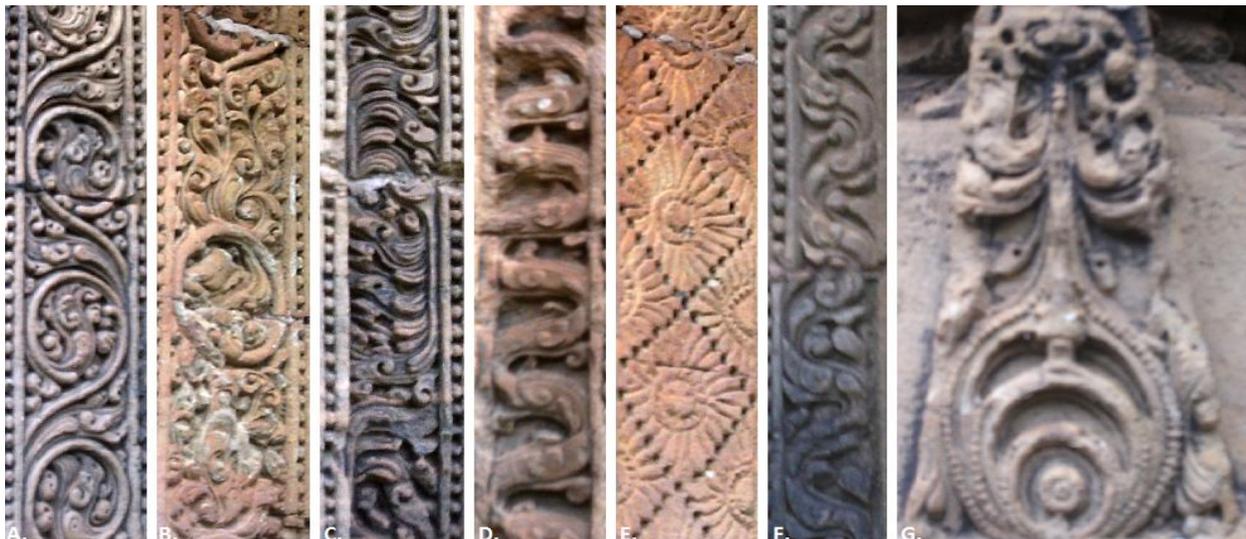
**Image-11: Different panels carrying floral forms installed on *Chitrakarini* Temple walls  
(Photography by author)**

Different biological and other forms were found over the wall panels of temple. These forms could be categorized as murals in majority of the cases, as most of them had been incorporated over two-dimensional stone slabs; which were further placed over the main temple's wall panels. However, few of them also had three dimensional characteristics as well, like image-11(G.); and so this panel could be considered as a wall mounted sculpture.

The walls panels of *Chitrakarini Temple* were ably demonstrated as the great treasury of wall mounted murals. These murals were precisely chiseled and mounted all around the temple walls and carrying great legacy of stone craftsmanship of CE 13<sup>th</sup> century. Mural panels displayed in images-11(A,B,C,E&F) were inspired from different floral forms; while image-11(D) was inspired from the abdominal form of snake; while the form displayed in image-11(G) had been identified inspired from the vagina- the biological feminine reproductive organ.

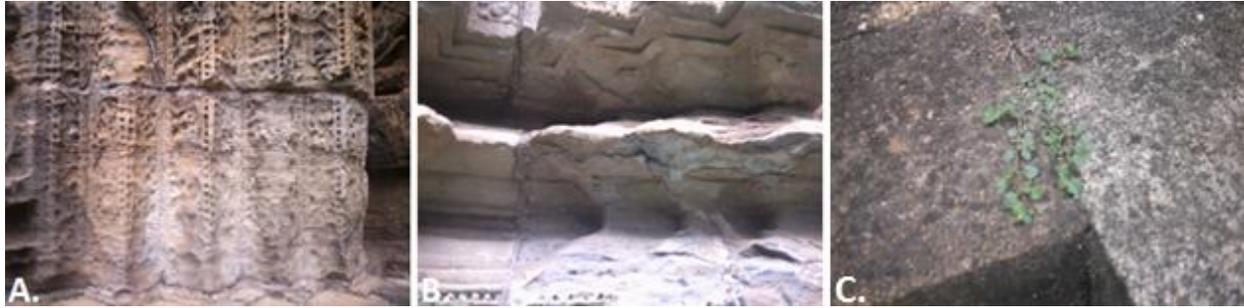
**Image-13: (A.) A panel with climate-washed artifacts, (B.) A climate caused self-chipping stone structures near temple foundation, (C.) An example of growing plant from a stone block join of the main temple's foundation, which may cause further damages with its growing root strength inside this joint (Photography by author)**

According to the above referred document, local atmospheric conditions affected the decay in upper and inner layers of the sculptural artifacts of this temple. These sculptures and architectural structures were found with poorly faded surfaces and the upper carved surfaces of these structures and sculptures were coming out in the form of dusts, and were attaining faded visual appearance and weakening internal structures. Some of the panels could be referred through image-13(A&B). At several points, serious stone cracks had also been identified by this researcher.

Near lower foundation area, unwanted growth of plants between the stone-block joints had also been found; which is enough for these unwanted herbs to cause damages in the lower foundation area for *Chitrakarini Temple's* existing structure, which had travelled centuries long journey till date. An existing example of this factor is displayed through image-13(C), which is also an unignorable responsible factor for existing nature caused damages in lower foundational structures<sup>52</sup>, along with the local atmospheric conditions.

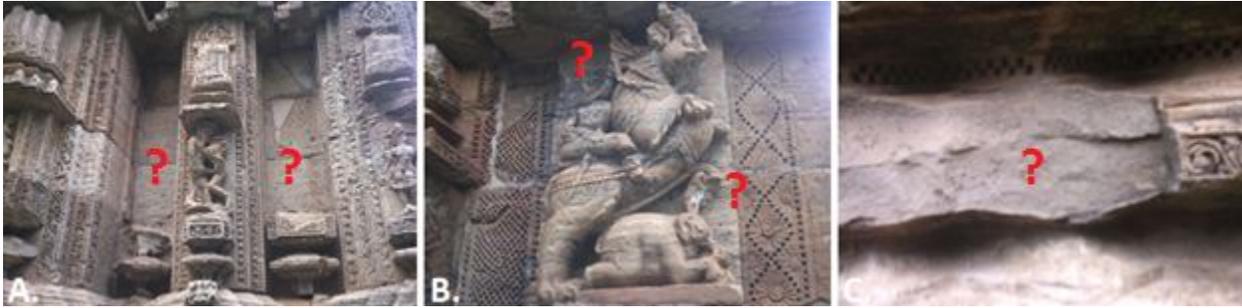
**Image-14: (A.) A wall panel with two missing sculptures- Both bases remain, (B.) A deliberately half-damaged sculpture remain, (C.) A deliberately damaged panel with clearly visible chiseling marks (Photography by author)**

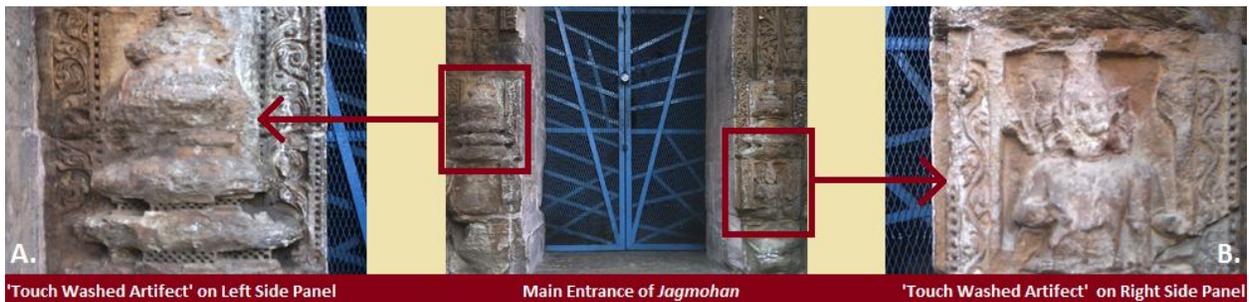
**Image-15: Touch washed sculpted stone forms at the main entrance side-panels of Jagmohan in Chitrakarini Temple: (A.) Left Side Panel, (B.) Right Side Panel (Photography and Illustration by author)**

This had been observed that the major damages had been occurred in two parts of human-similar idol's face and leg parts. The leg part got completely damaged due to regular *Charan-Sparsh*<sup>58</sup>

practices by the pool of devotees; while, the face parts got damaged due to the regular offering *Naivedy*<sup>59</sup>, like- sweets and other edibles- through pouring them into the lips and mouth region of such stone idols; please refer image-15(B). Other sculpted stone artifacts over the main entrance of this temple's *Jagmohan* was also found touch-washed, due to regular holistic touch by devotees, please refer left panel artifact, as displayed in image-15(A). In Hinduism, touching the deity's idol is a common and regular practice, which is responsible for these sculptural damages. Here this researcher wishes to mention that idol-touch practices should be avoided by the pool of devotees to preserve the sculpted-glory of any idol; as after all any human creation may get its physical shape using a material; and every material available over this earth has only a certain life-time, and is equally applicable for any stone structure as well.

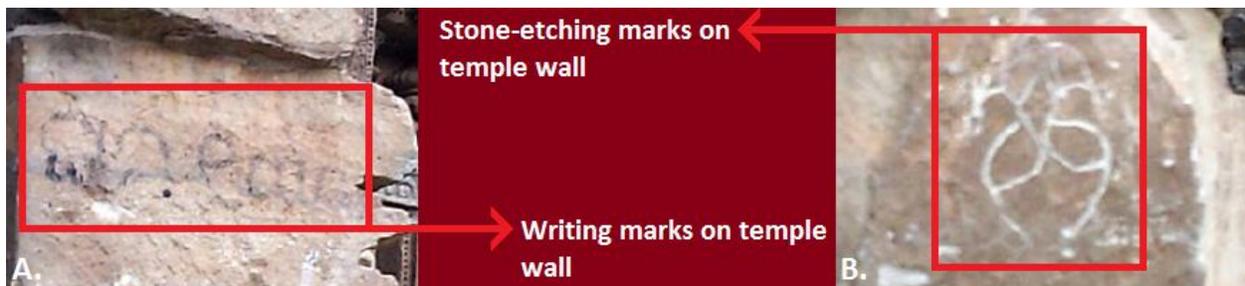
**Image-16: (A.) Wall writing, (B.) Etching marks; over stone panels of *Chitrakarini Temple* (Photography and Illustration by author)**

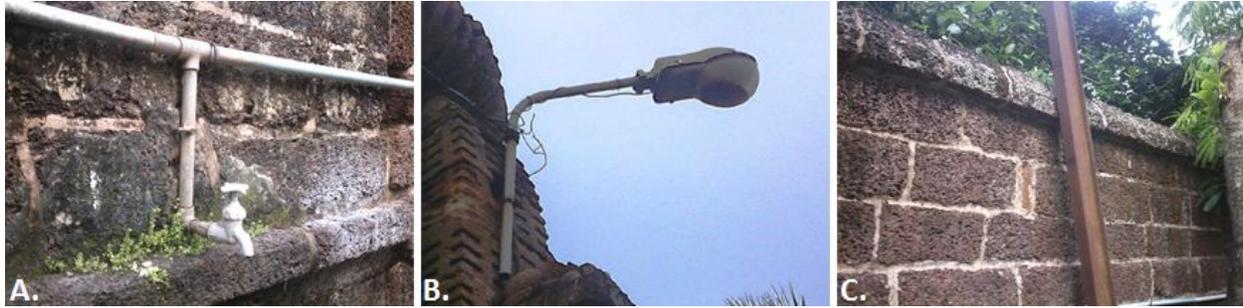
To extend the quality of basic utility needs, different technology driven systems had been installed in recent years within the *Chitrakarini temple* premises; among which importantly two classes of such systems had been found installed within the temple premises: (1.) Electricity based night lightning system installations, and (2.) Water supply system installations etc. However, such executions enhanced the quality of public utility facilities within temple premises; but as such installations were incorporated directly over the stone structures of this 13<sup>th</sup> century old monument<sup>61</sup>, were found responsible to reduce the 'material-life' of this centuries old stone structure- which was found already suffering with serious stone decays and damages- due to the local nature caused atmospheric and other conditions. Further, this researcher had also observed lack in periodically required, post-installation maintenance. An example could be referred through image-17(C); where an electric pole, found leaning over the boundary wall of this temple and was about to damage this permanent structure- if not been adjusted on a priority basis. Some of the other findings has also been referred in images-18, 19, 20 etc. further.

**Image-17: Amenity enhancement systems within Temple premises in *Chitrakarini Temple* (Photography by author)**

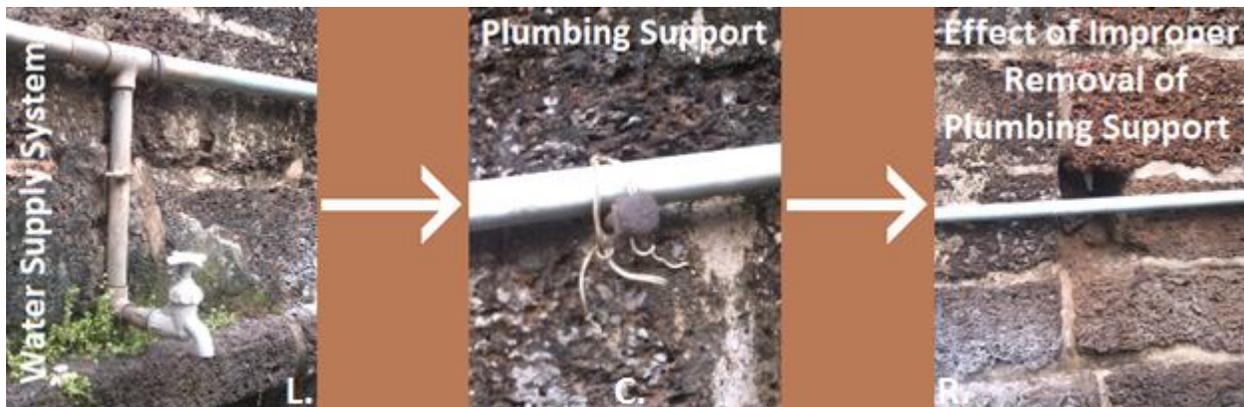
Role of the fresh water supply had always been in prime importance at any religious premise across the religions<sup>62</sup>, to support its daily socio-cultural needs. Over the eastern wall of this monumental premise, there is Poly Vinyl Chloride<sup>63</sup> based water supply system had been installed as displayed in image-17(A), with wrought iron made fixtures. These fixtures, as shown in image-18(C) were directly installed over this stone wall by penetrating its surface- this may offer cracks, groves etc. in such wall panels- when these non-coated iron fixtures get rusted<sup>64</sup> and produce different oxidized residues while gradually exposed with atmospheric oxygen and moisture, which results volume expansion in oxidized iron; but as stone and cement can't expand as much, so getting cracks- and this way the entire wall structures may receive negative impact. The mark of an improperly execute plumbing system repair could be referred through image-18(R); where the stone block had been removed, while unclamping the old fixture.

**Image-18: A damage caused by the improper maintenance of water supply system on *Chitrakarini Temple* premise wall (Photography & Illustration by author)**

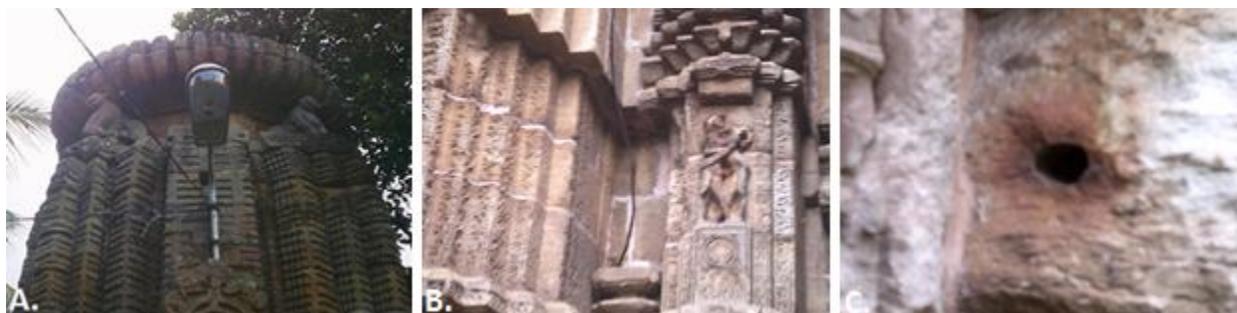
direct placements of iron nails and clamps, even this researcher had observed different holes with chiseling marks over this temple complex wall panels. Use of the external side pales found advisable for such electrification works, to preserve this temple for further generations.

**Image-19: Electrification in Chitrankarini Temple (A.) A lightning system- directly installed over the Temple panel, (B.) A functional electric wire- hanging along with the temple's external wall, (C.) An electrification purpose hole over the temple panel (Photography by author)**

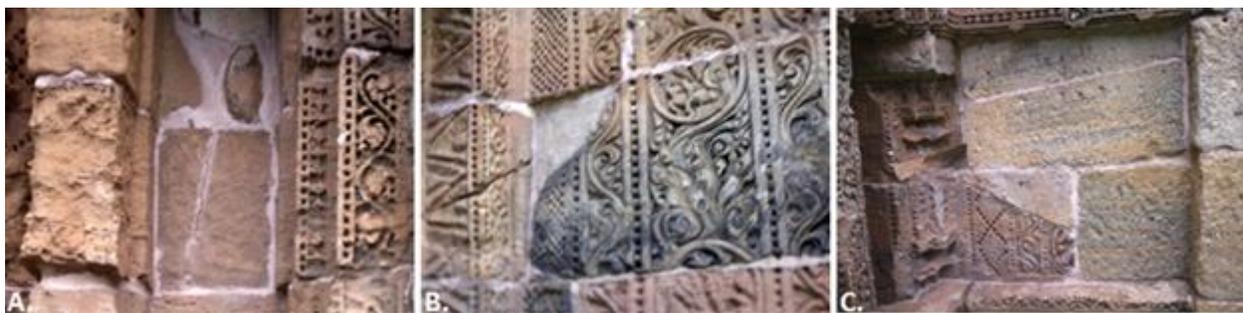
**Image-21: Restored two-dimensional structures and murals: (A.) A cement filled, poorly damaged wall crack, (B.) A restored two-dimensional mural slabs with re-cemented joints, (C.) A poorly damaged originally sculpted wall panel restored using non-sculpted sand stone blocks- to protect this panel's strength (Photographs by author)**

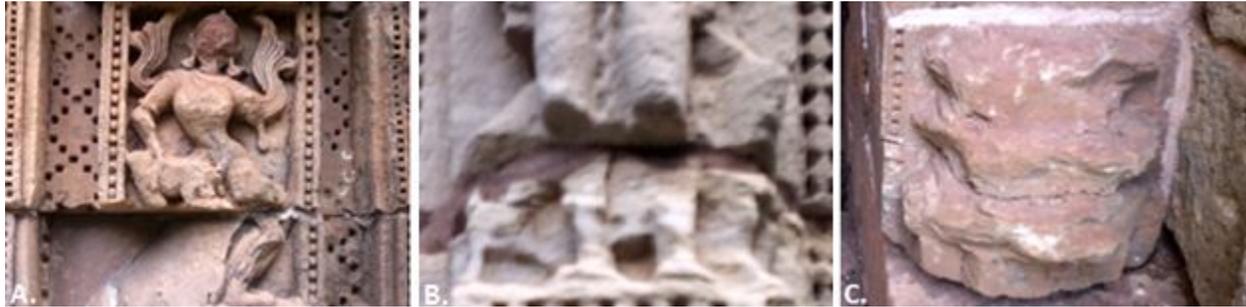
**Image-22: Existing conditions of three-dimensional sculptures: (A.) A sculpture with completely lost its lower half section and damaged face, (B.) A poorly damaged sculpted section, where cement had been applied to cover the upper surface of stone joints, while the three dimensional sculptural form is untreated, (C.) A completely lost sculpture remain- in completely unidentifiable status (Photographs by author)**

So, however this research appreciates the existing condition of restoration, but also criticizing this segment of ignorance, which was also supposed to be explored by the team of restorers. And so, this temple was still found in the need of three-dimensional sculptural restoration, and allowing sufficient space for further improvements, to re-achieve its previous-similar sculptural glory.

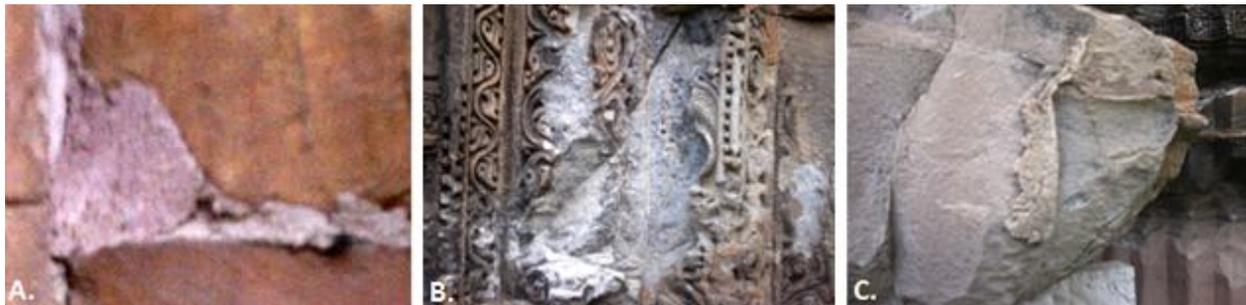
**Image-23: (A.) View of a post application un-evened cement decomposition, (B.) A wall with artifacts get uncleaned by the excessive use of restoration material, (C.) View of a used cementing material mass, which was unable to hold its cemented extension (Photographs by author)**

Even, there were several examples had been identified, where cementing materials had not been cleaned up by the team of restorers, and now causing untidy visual appearance; please refer image-23(A)- this should be evened, using a piece of fabric- while the cementing material was in pouring condition. Few other sections of this temple's wall panels had been found extremely dirty, due to the improper spread of restoration materials and cracks were only partially treated; please refer image-23(B). This researcher was shocked to found a section of wall panel, where the used restoration cement was spread massively; and self-explaining that the used cement was unable to

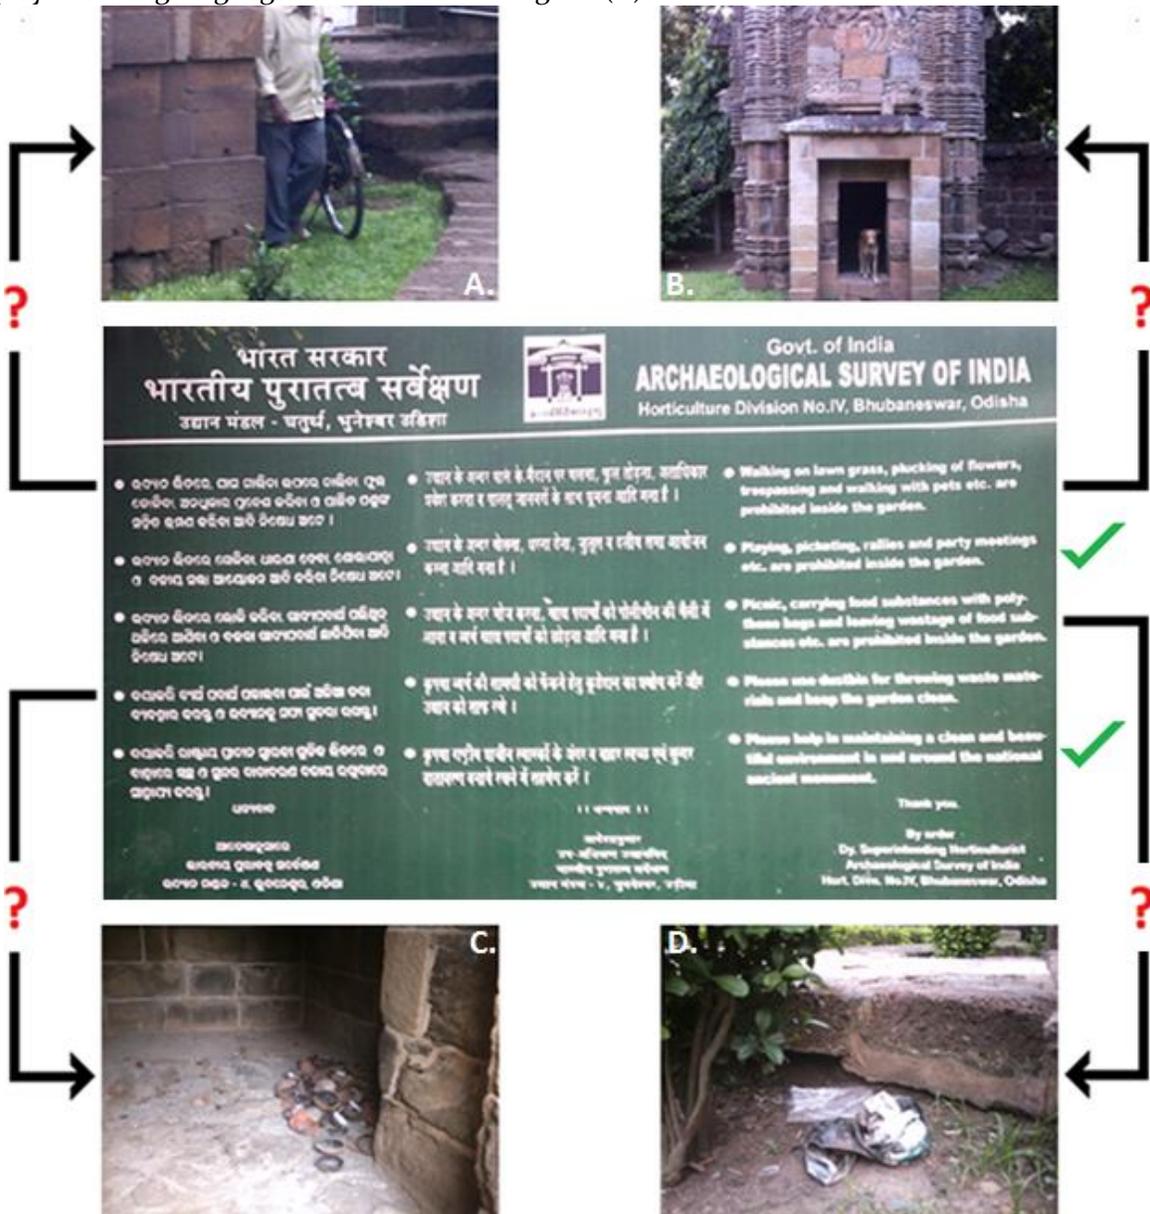
**Image-25: A few cases of ignorance at local level towards government orders displayed in signage installation in Chitrakarini Temple premises: (A.) A local visitor walking on garden grass along with his bicycle, (B.) A street dog residing in a peripheral temple (without any existing idol) as her home- became stand with aggression at temple's door- as disturbed by the unexpected presence of this researcher, (C.) Next peripheral temple (also without any existing idol)- used as the junk yard for the post worshipped-used oil lamps, (D.) A bunch of used local food packaging left out (oil washed newspapers and polyethylene bags) (Photographs and illustration by author)**

This researcher appreciates the rigorous efforts made by the Horticulture Division-IV, Bhubaneswar of the Archeological Survey of India, in the direction to restore this temple's surrounding ambience. During his field visit, this researcher came across with a couple of findings on an actual basis, where government orders and above efforts had been ignored<sup>74</sup> at local level. Here this has been found important to mention, that the purpose of highlighting such findings by this researcher is purely holistic towards attracting the Local Community Supports<sup>75</sup>- as this temple and its premise carries their native socio-cultural and religious values since last 900 years and so they cannot ignore their responsibilities to maintain their own surroundings clean and presentable to the remaining world. So, if government agencies are initiating some welcoming

steps, they should at least support such initiatives at local level, by respecting basic guidelines, as displayed through signage instructions in image-20(C).
